Geophysical Investigation of Flood Control Levees in the Sacramento-San Joaquin Estuary, CA.

FERRIZ, Horacio, SANDHU, Resham, LOOGMAN, Ashley, GALBREATH, Stacey, Department of Physics and Geology, California State University, Stanislaus, One University Circle, Turlock, CA 95382

The Levee Project

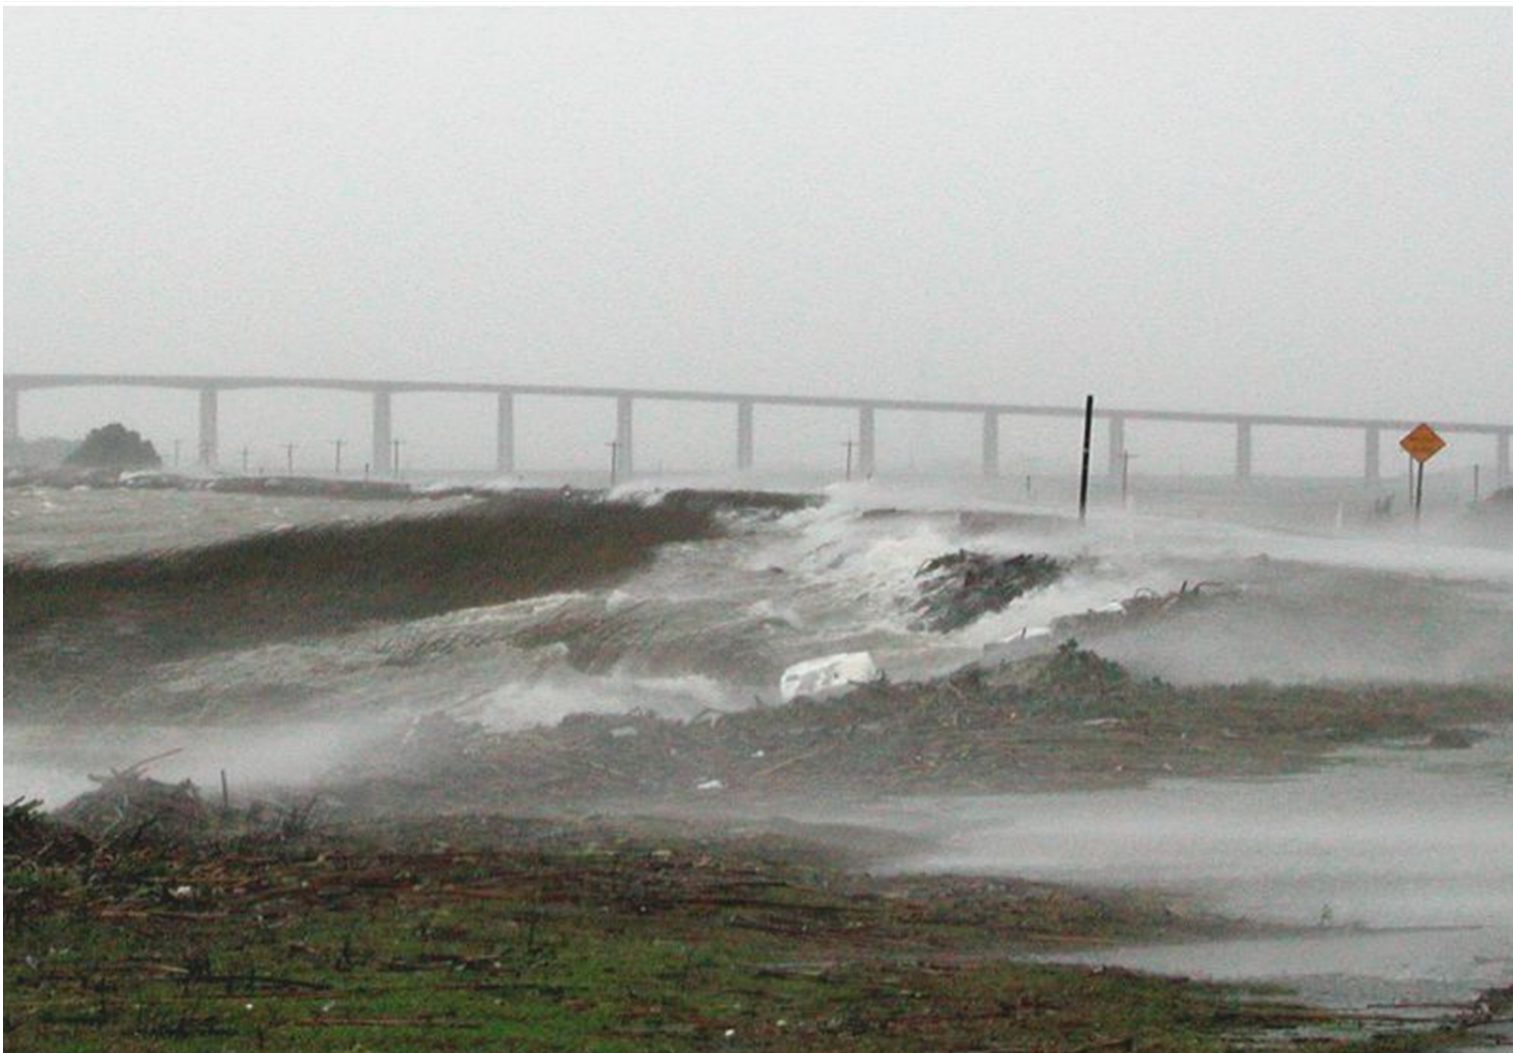
Figure 3 : The surge of water caused by the 1969 levee break on the South side of Sherman Island.

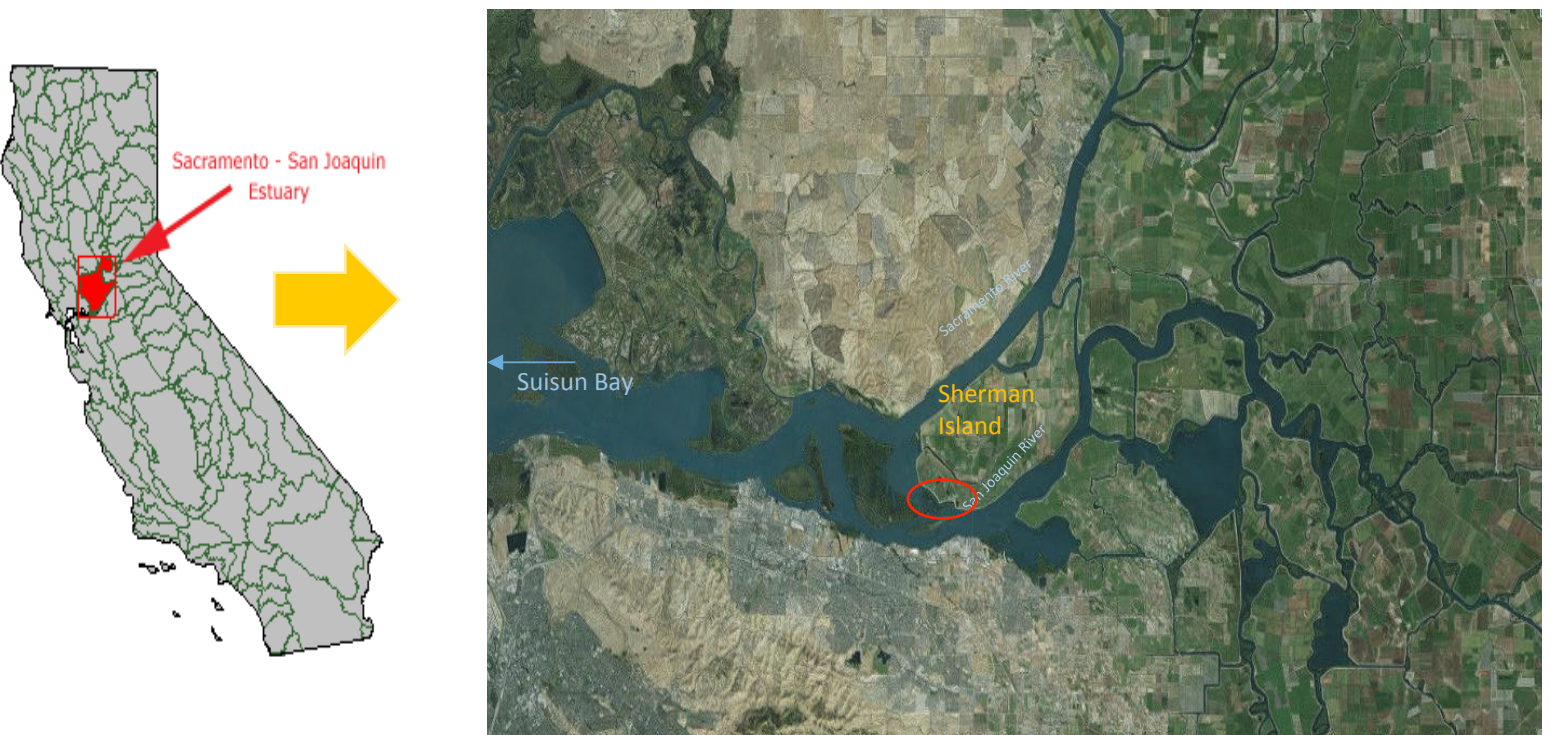
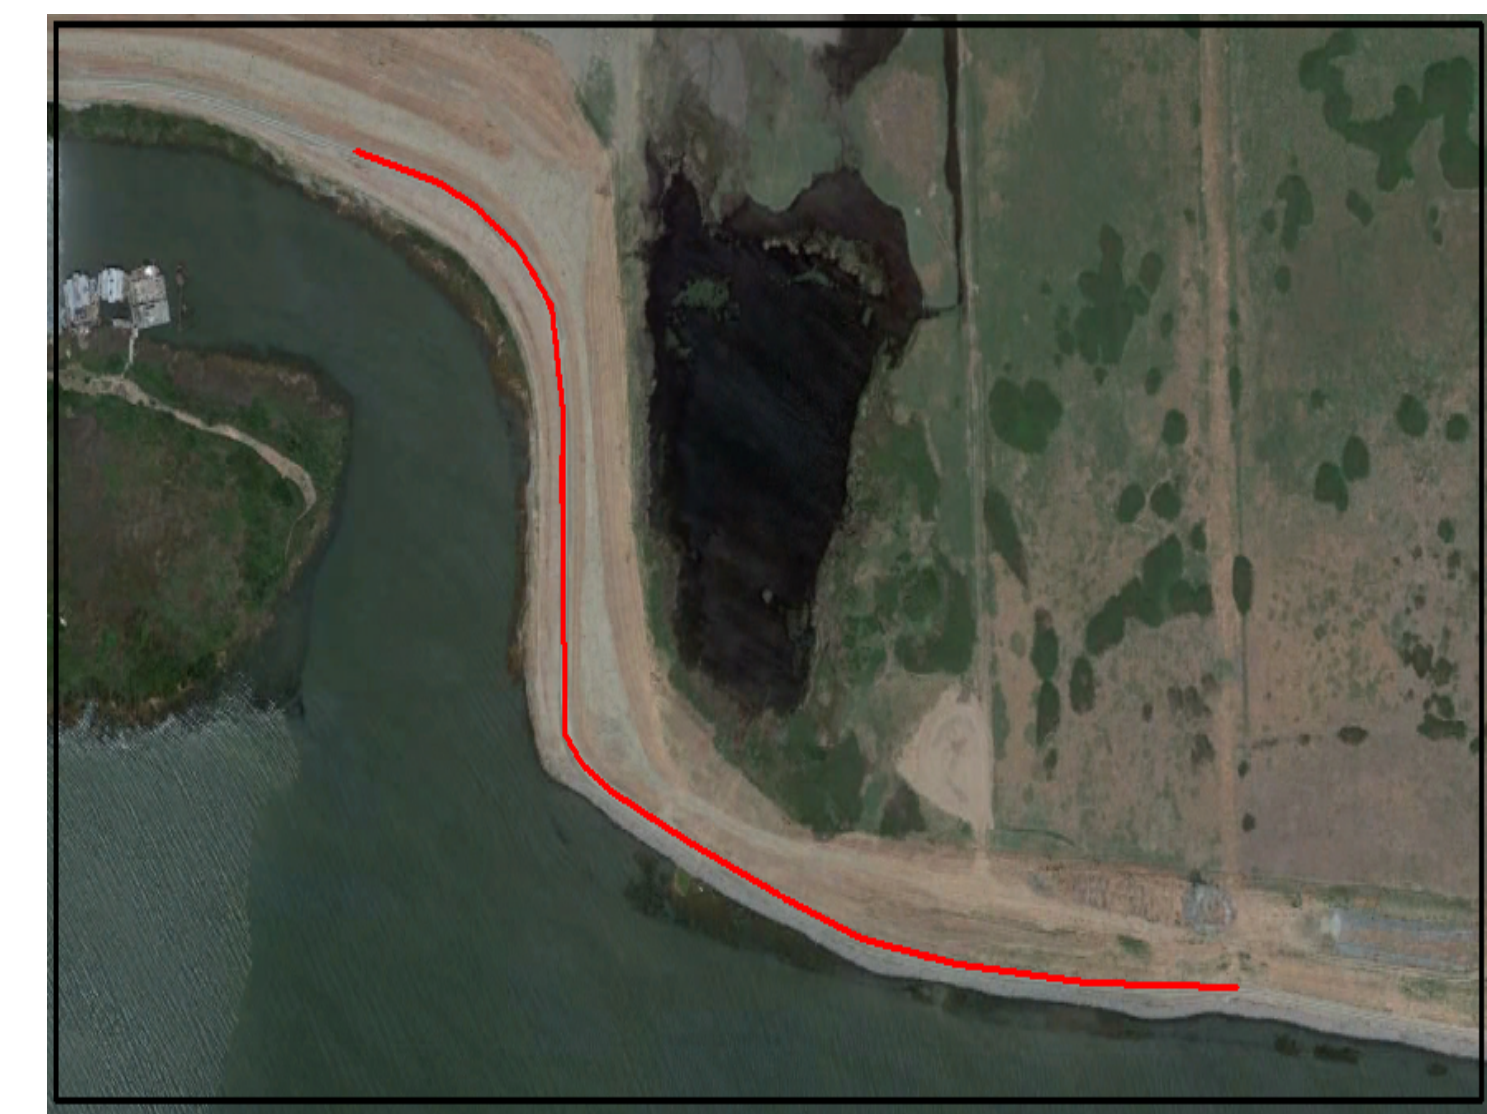
Figure 1: Images of the research area.
